GRT Avionics 3133 Madison Ave SE Wyoming, MI 49548 616-245-7700 support@grtavionics.com

Subject: EFIS Rotary Encoder Knob - SB-0001

Models Affected: Sport HS, SX and Horizon HS, HX

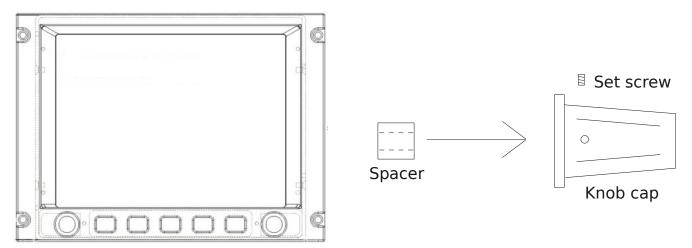
GRT Avionics has determined the set screw that holds the rotary encoder knob cap to the rotary encoder shaft may come loose over time rendering the rotary encoder inoperable with the knob cap in place.

Use a 0.050 inch Allen wrench. Loosen the set screw and remove the knob cap from the rotary encoder shaft.

Insert supplied spacer into the knob cap as far in as possible until seated in the knob cap.

Replace knob cap onto rotary encoder shaft. There should be approximately 1/16 inch spacing between the EFIS bezel face and the knob cap skirt.

Tighten set screw.

Operate the knob/rotary encoder to check for proper operation. The rotary encoder should "click" when pressed and rotate/"click" when turned.
